Case Study – Christian Raddich
Hull Cleaning (Pressure Washing)

Job No – D/5070

Date – Saturday 7th July 2018

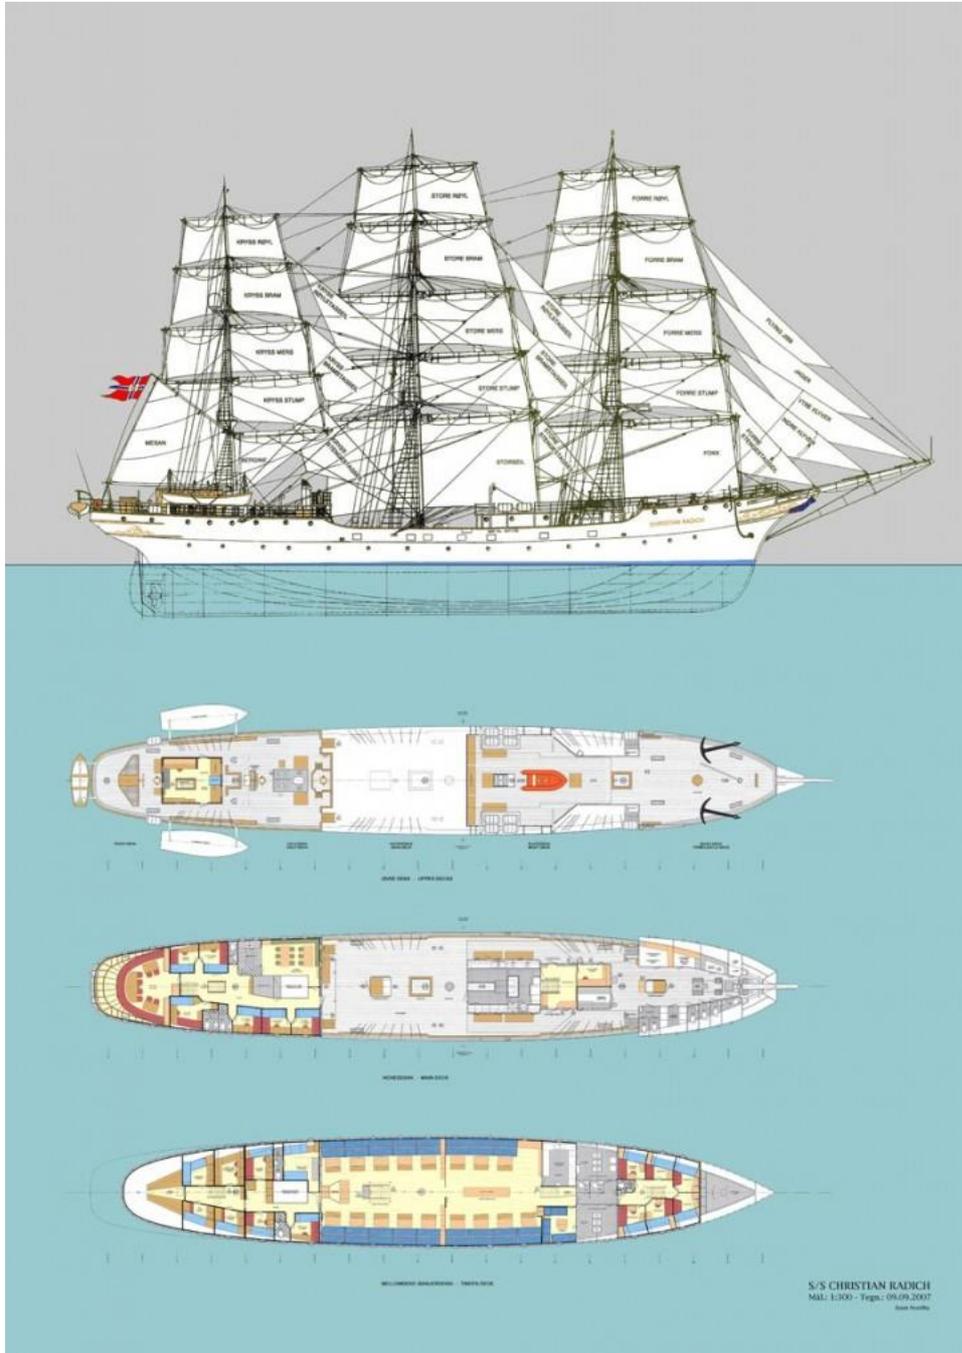
Vessel Diagram

The first task carried out is a brief AS Found survey of the vessel to allow the client to have a visual reference of the marine growth coverage on the vessel. The Vessel had an extensive coverage of soft marine growth over the full hull, stern gear, connection points and the rudder. We agreed with the Client that we would clean a 3metre band from Bow to Stern using a pressure washer with more attention focused on the FWD Bow section. The blades required cleaned and a GVI (General Visual Inspection) under Client supervision, carried out by the Diver to allow the Client make a decision if a propeller polish would be required.
